Seattle Pedestrian Advisory Board

11/10/21

Judkins Park Station

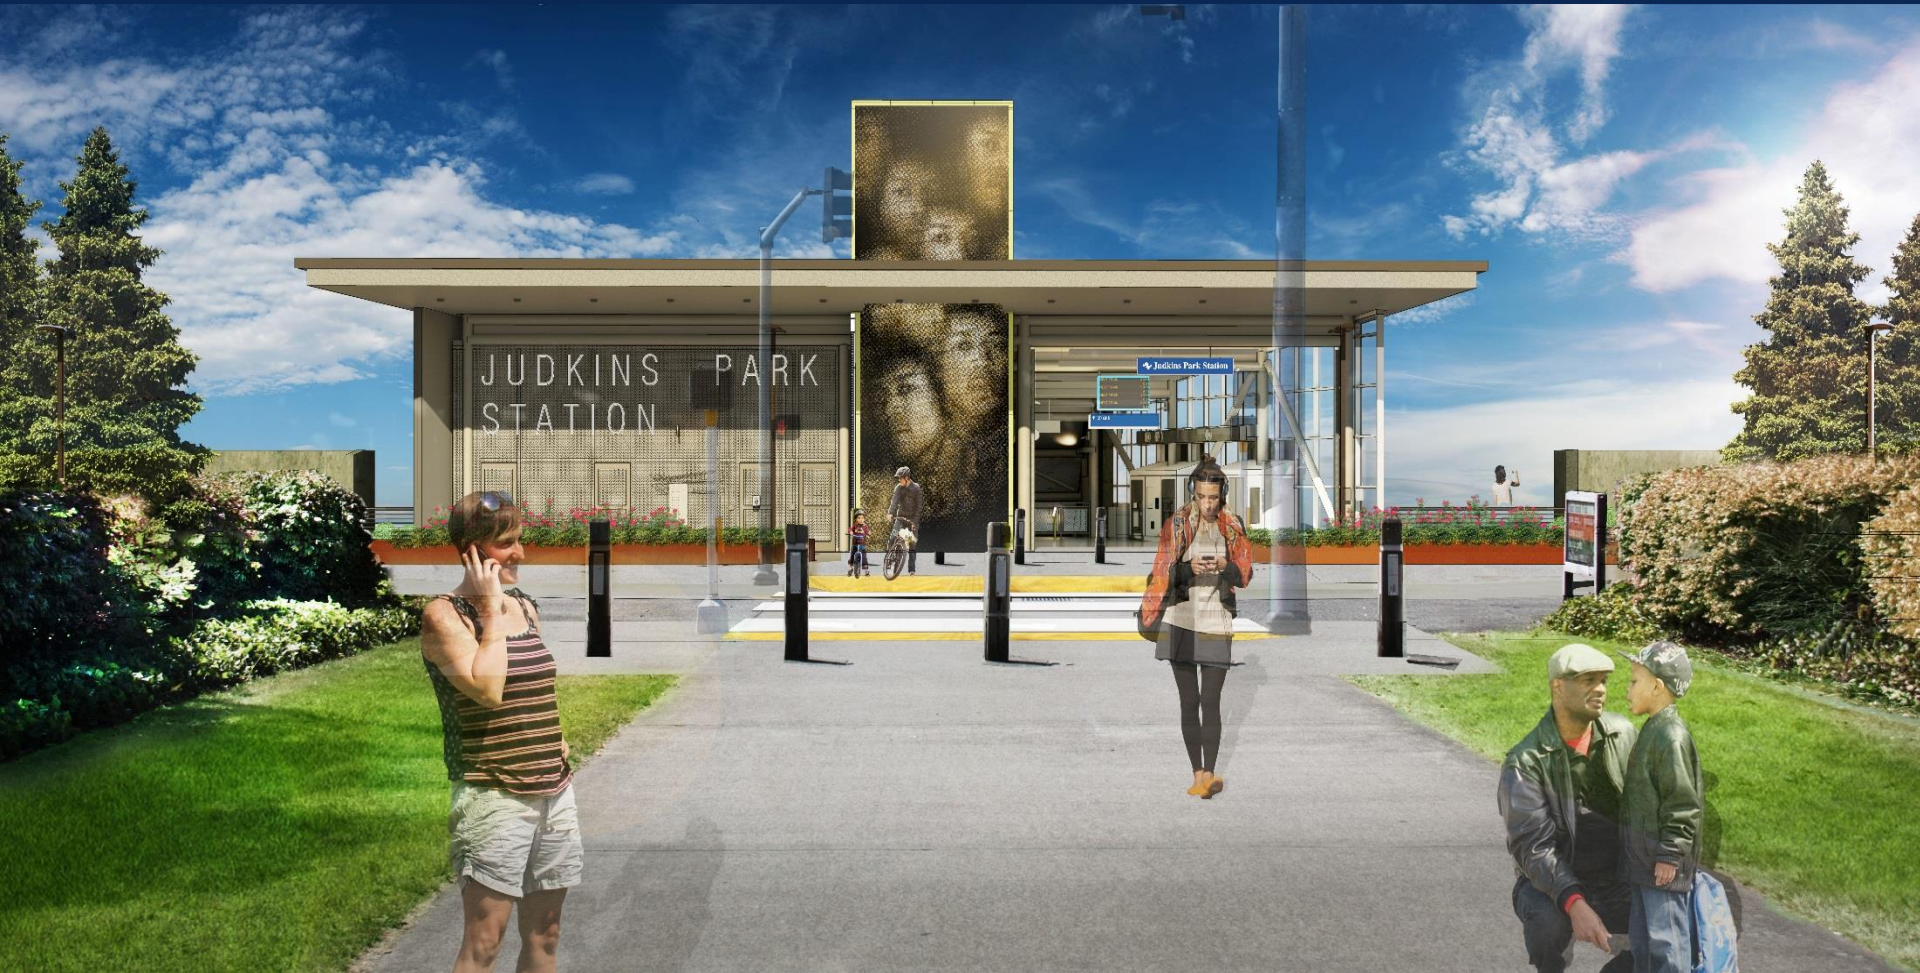
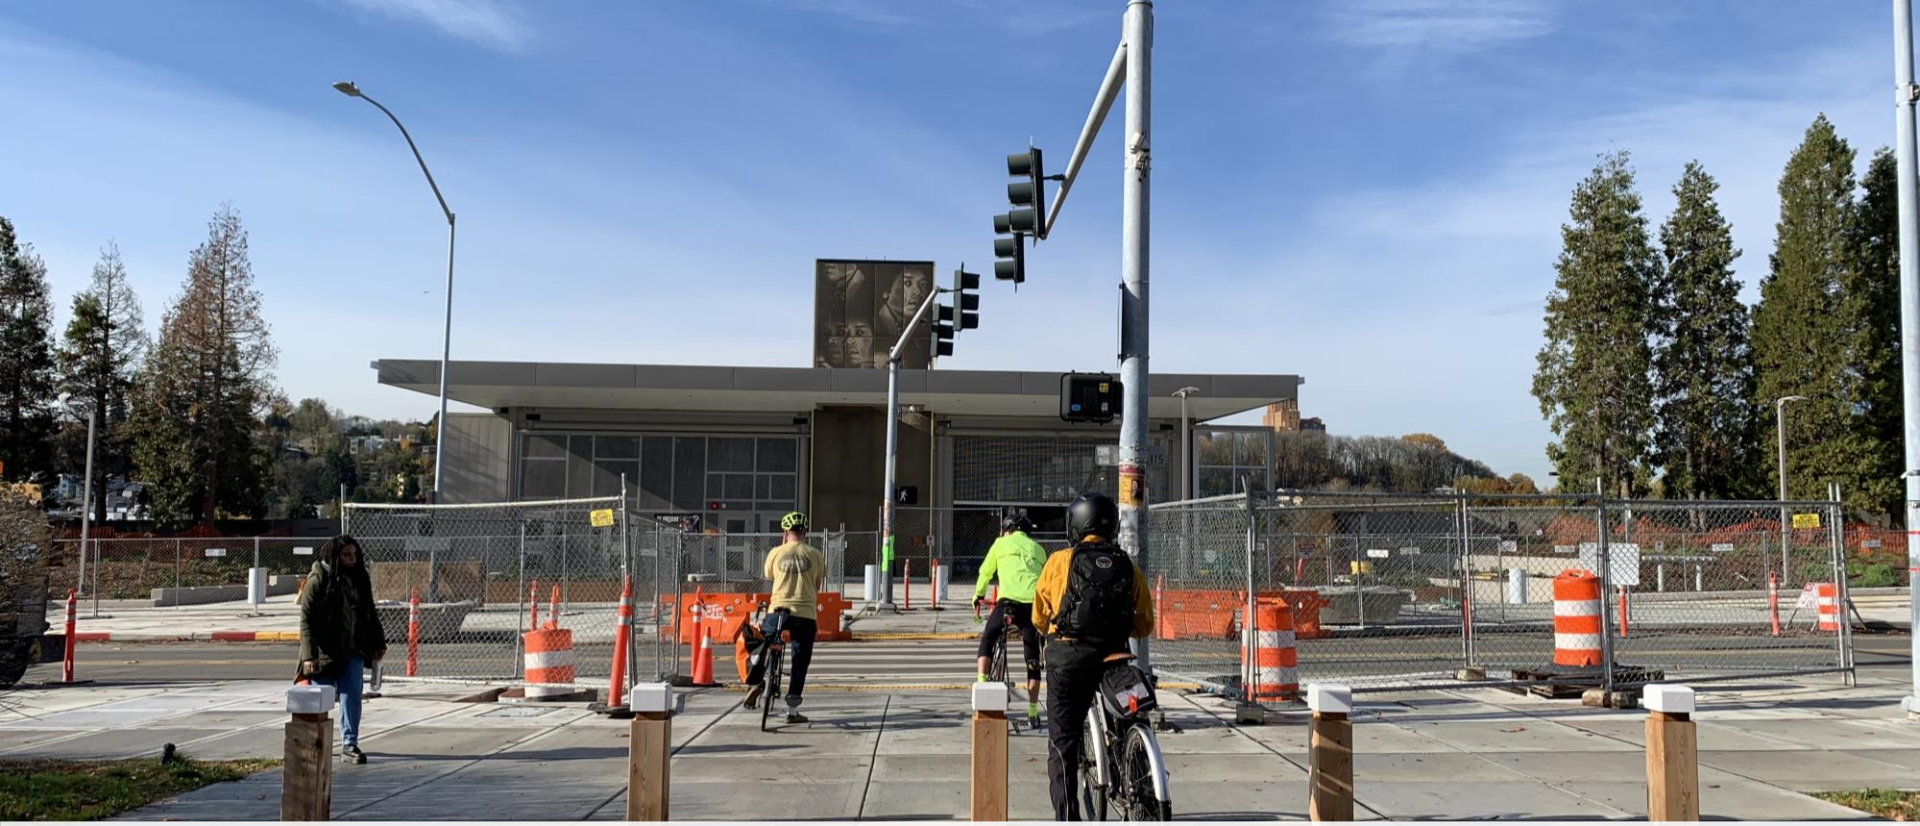
Station Entrance at 23rd Avenue South

Station Entrance 23rd Avenue South

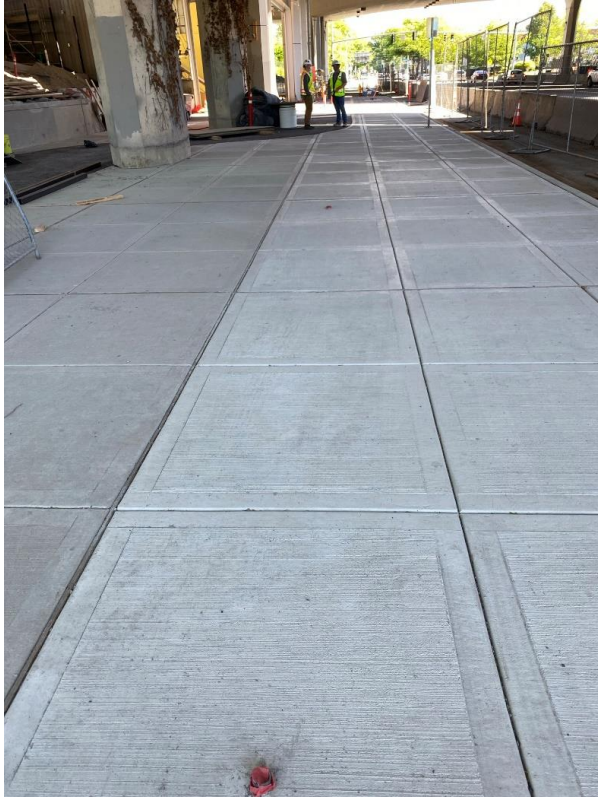
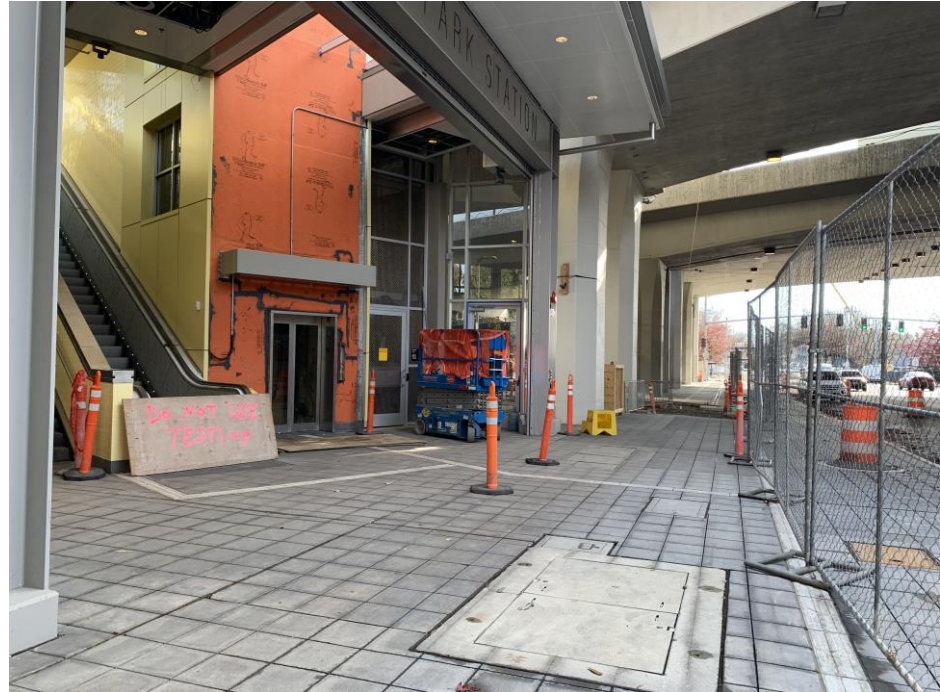
West Entry – at Rainier Ave S

- Sidewalk widened by 8 feet

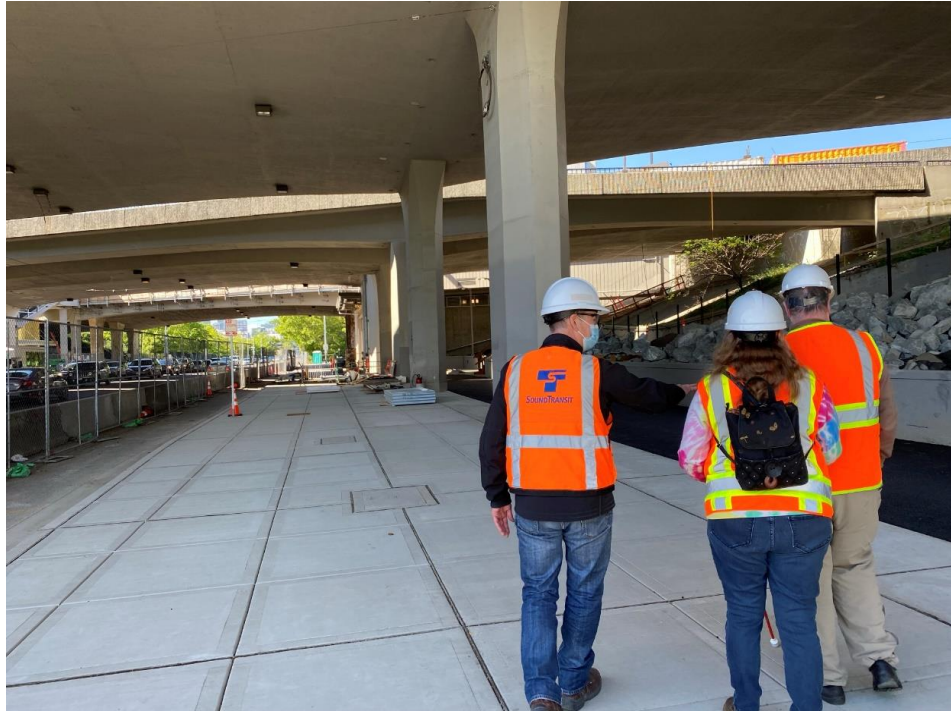
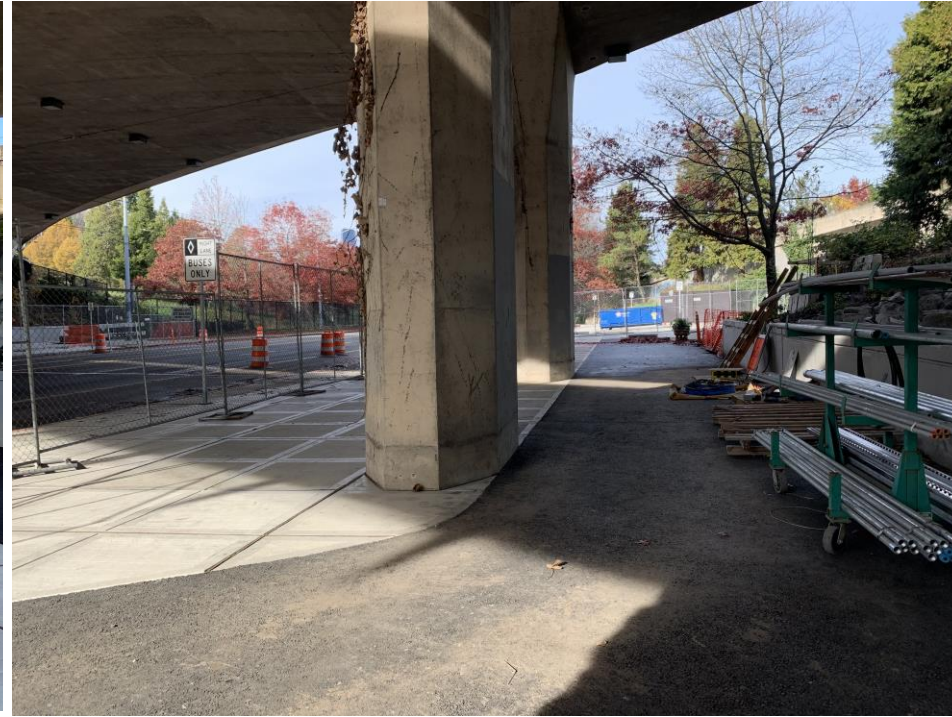
West Entry – Bike and Pedestrian Path north of station

Bike path - tactile strip has not been installed yet

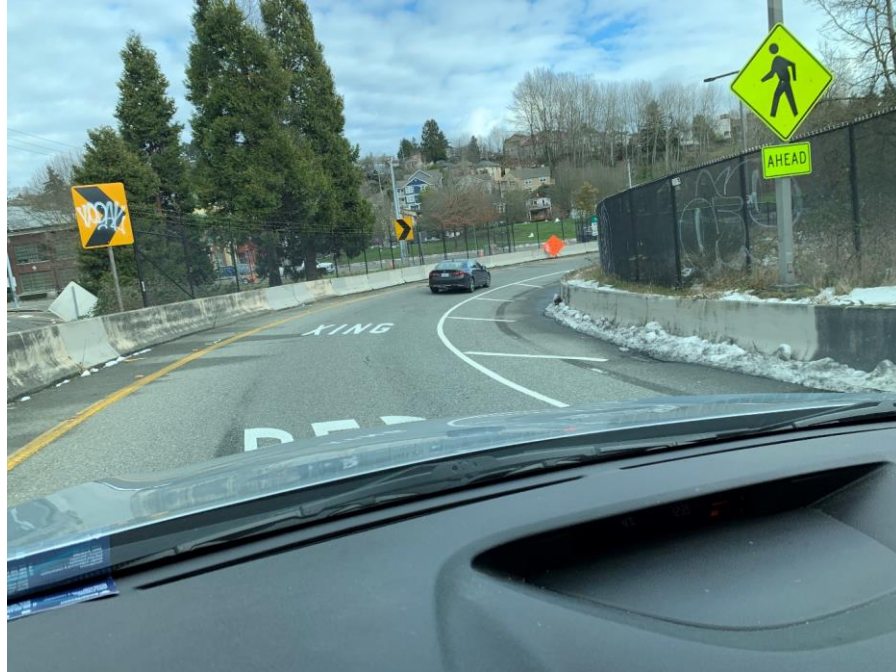
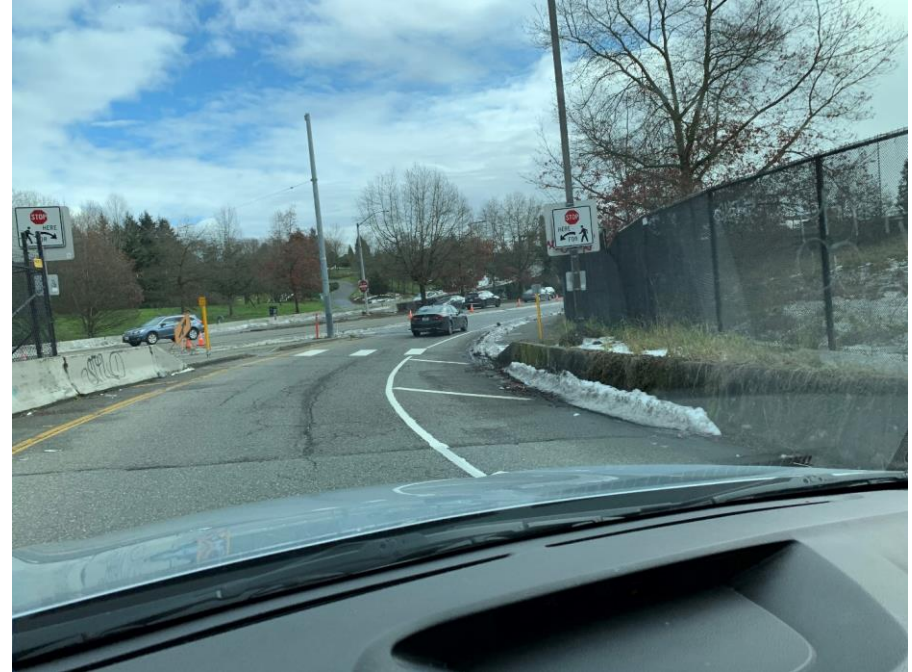
Judkins Park Station – WSDOT RAMPS

West Bound I-90 off ramp to South Bound Rainier
(north of JPS) from the Drivers perspective .

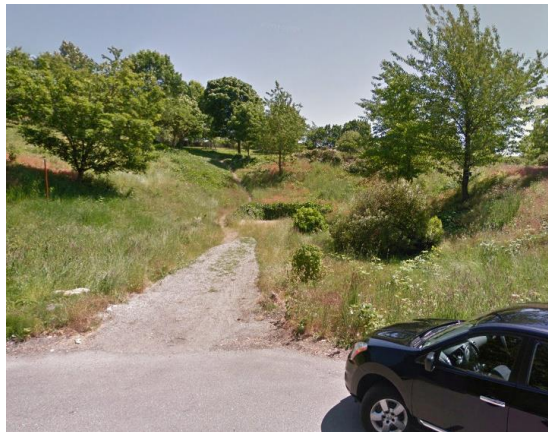
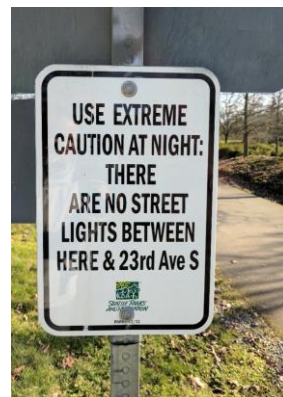
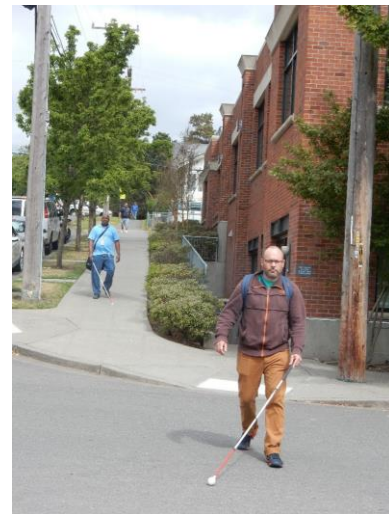
- In September 2019 Sound Transit awarded City of Seattle \$2.4M from System Access Fund for Judkins Park Station Access
- Includes design and construction for sidewalk upgrades, Hiawatha Place staircase and trail

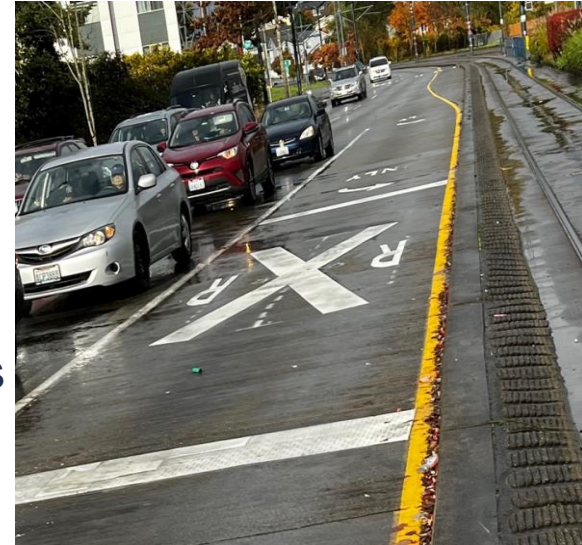
- ST at-grade crossing treatments currently meet ADA requirements
- 2017 and 2019 Safety Studies – in coordination with SDOT
- Relocated audible devices at the end of the station platforms
 - Provides additional warning to pedestrians and vehicles
- Installed Railroad Pavement Markings (RXR)
 - Left turn lanes along MLK

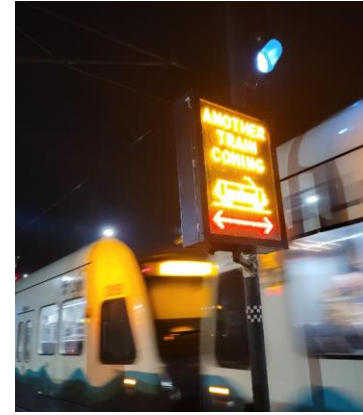
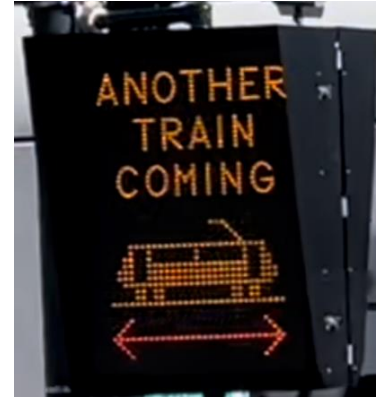
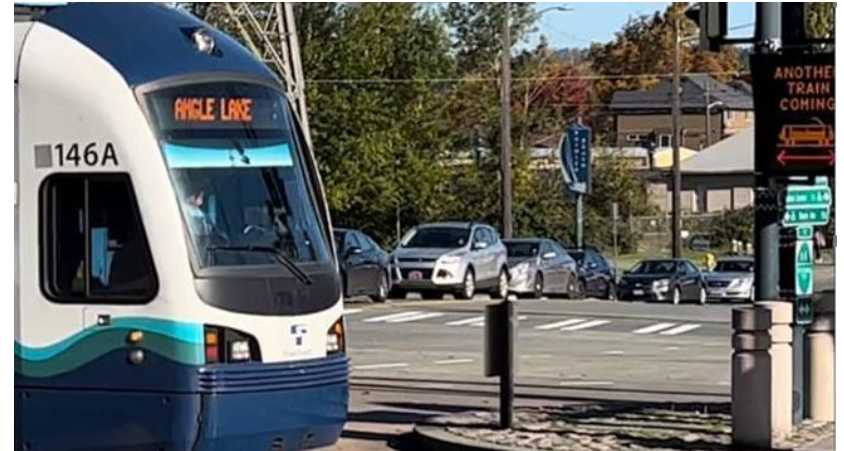
- Rainier Beach Station (Installed)
 - ANOTHER TRAIN COMING sign for pedestrians exiting the station
 - New Pedestrian Warning signs (replaced old signs)
- Other Stations (in coming months)
 - Similar Signage

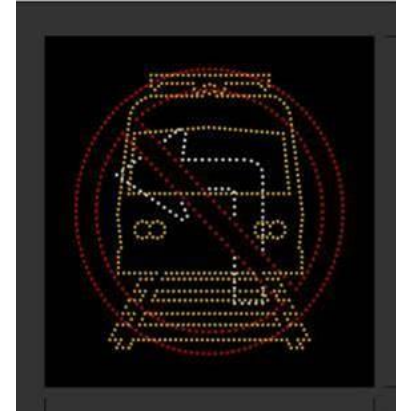
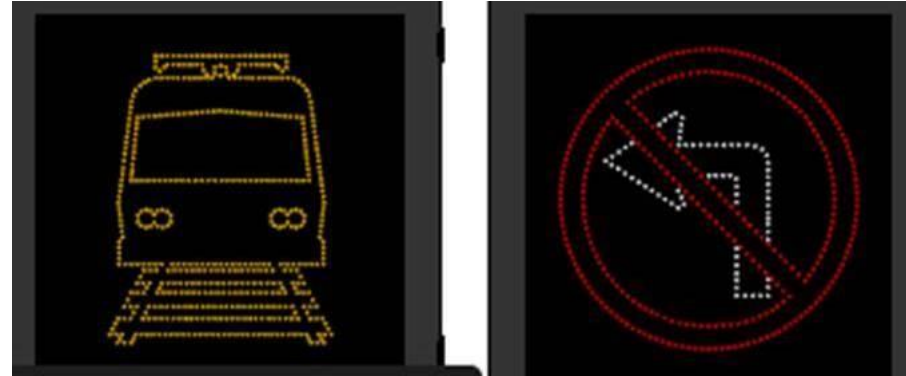
- All MLK crossings
 - Replace existing Train Warning signs for left turn vehicles with new signs
 - Alternatively flash Light Rail Symbol and NO LEFT TURN during train presence
 - To be installed in coming months
